# SCHEMATIC VIEW OF GOONGUMPAS SUPPLY PIPES (E&OE MARCH 2015)

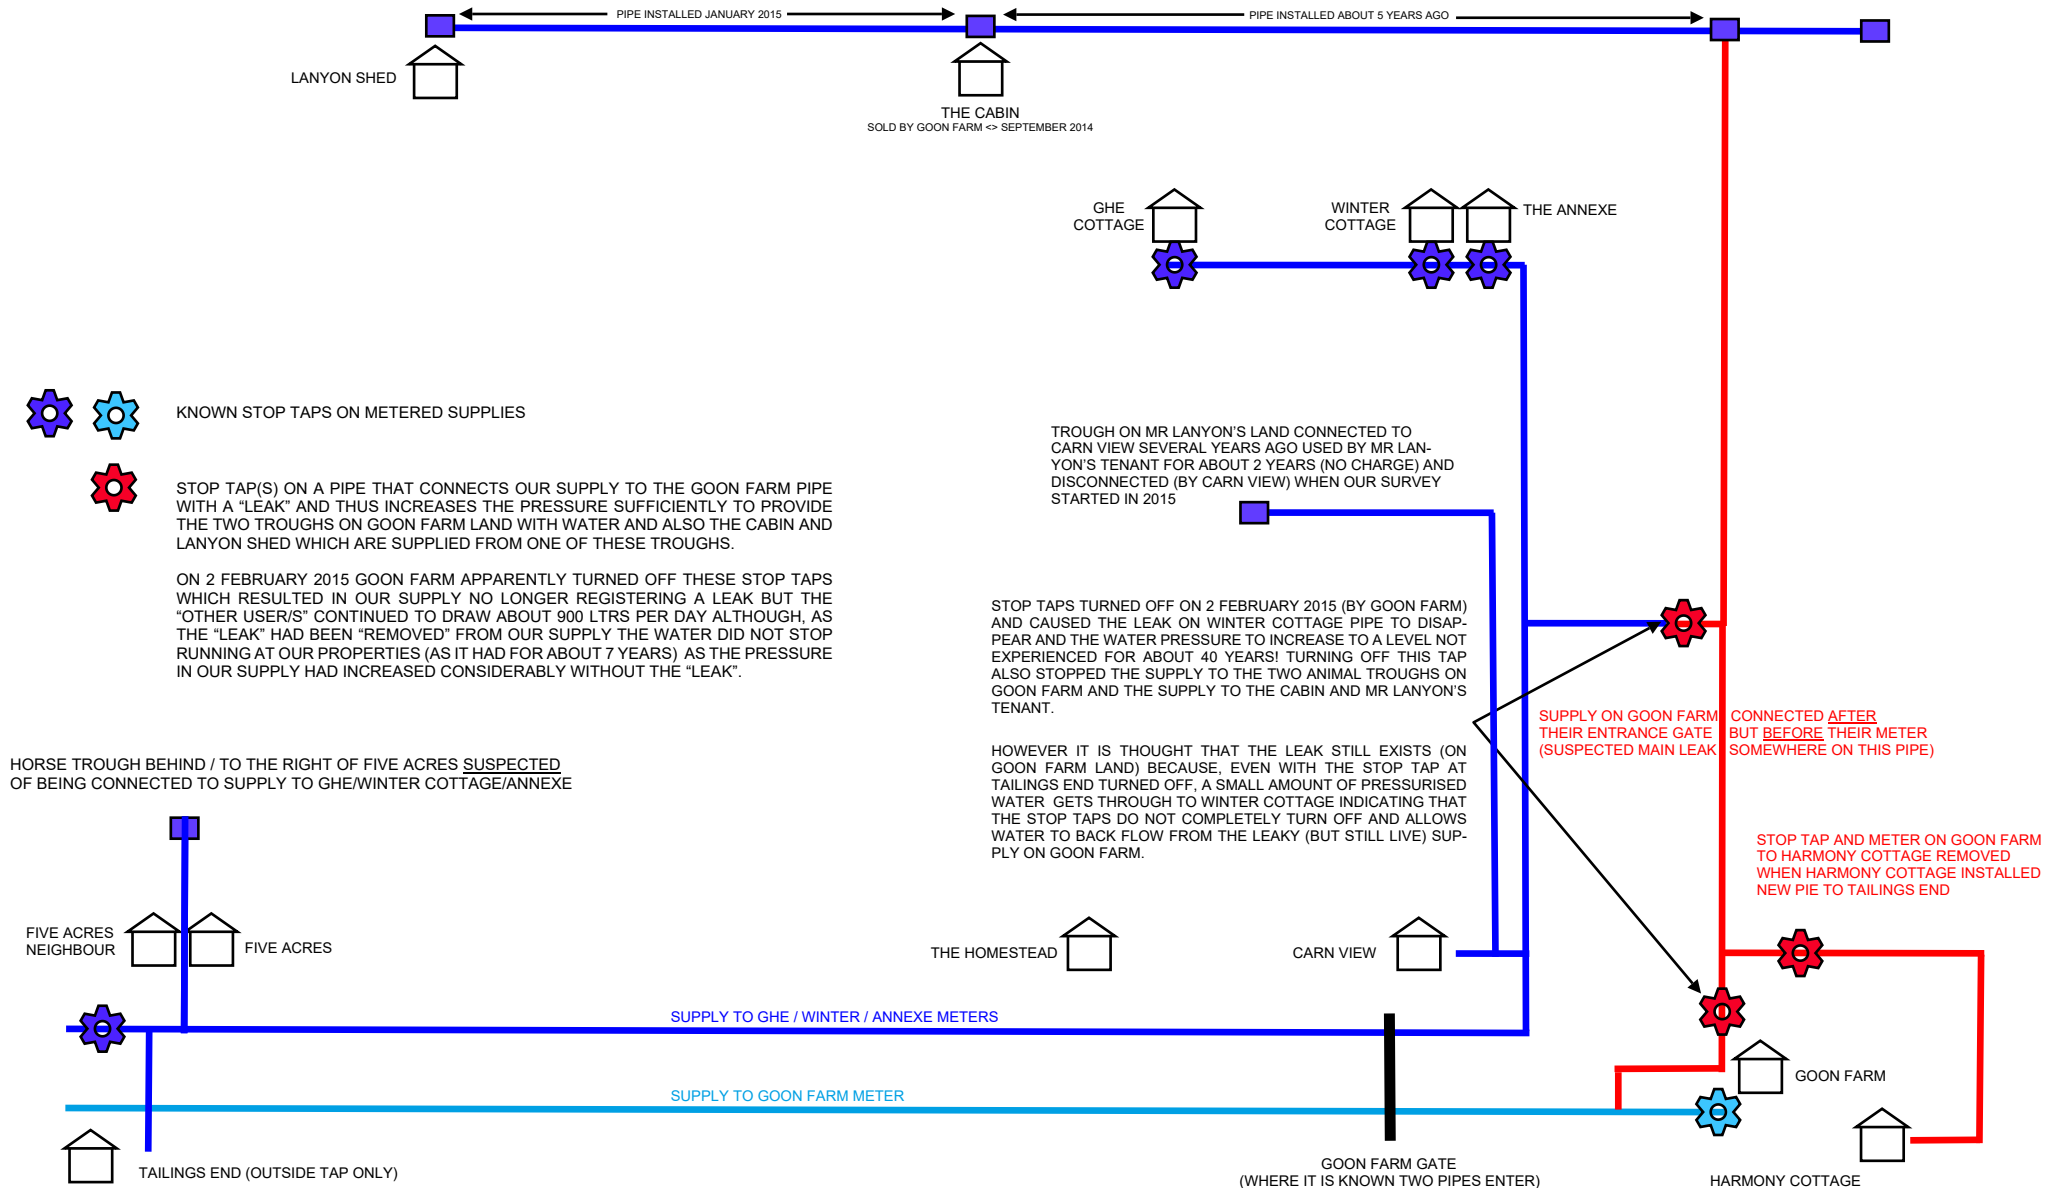
ANIMAL TROUGHS ON GOON FARM LAND FED FROM A GOON FARM PIPE WITH A SERIOUS "LEAK". THE LEFT TROUGH ALSO SUPPLIED THE CABIN WHICH IN TURN (AS FROM JANUARY 2015) SUPPLIED THE LANYON SHED. THE SUPPLY TO THESE TROUGHS CEASED WHEN WE TURNED THE STOP TAP AT TAILINGS END OFF ON 2 FEBRUARY 2015 SO IT CAN ONLY BE THAT THE WINTER COTTAGE, GHE AND ANNEXE SUPPLY WAS CONNECTED TO THE GOON FARM LEAKY PIPE AND, DESPITE THE LEAK, INCREASED THE PRESSURE SUFFICIENTLY TO GET WATER TO THESE TROUGHS AND BEYOND. (EXCEPT WHEN ANOTHER USER CONNECTED FOR ABOUT AN HOUR DAILY WHICH CAUSED THE PRESSURE TO DROP TO SUCH AN EXTENT THE SUPPLY STOPPED).

STOP TAP(S) ON A PIPE THAT CONNECTS OUR SUPPLY TO THE GOON FARM PIPE WITH A "LEAK" AND THUS INCREASES THE PRESSURE SUFFICIENTLY TO PROVIDE THE TWO TROUGHS ON GOON FARM LAND WITH WATER AND ALSO THE CABIN AND LANYON SHED WHICH ARE SUPPLIED FROM ONE OF THESE TROUGHS.

ON 2 FEBRUARY 2015 GOON FARM APPARENTLY TURNED OFF THESE STOP TAPS WHICH RESULTED IN OUR SUPPLY NO LONGER REGISTERING A LEAK BUT THE "OTHER USER/S" CONTINUED TO DRAW ABOUT 900 LTRS PER DAY ALTHOUGH, AS THE "LEAK" HAD BEEN "REMOVED" FROM OUR SUPPLY THE WATER DID NOT STOP RUNNING AT OUR PROPERTIES (AS IT HAD FOR ABOUT 7 YEARS) AS THE PRESSURE IN OUR SUPPLY HAD INCREASED CONSIDERABLY WITHOUT THE "LEAK".

HORSE TROUGH BEHIND / TO THE RIGHT OF FIVE ACRES SUSPECTED OF BEING CONNECTED TO SUPPLY TO GHE/WINTER COTTAGE/ANNEXE

TROUGH ON MR LANYON'S LAND CONNECTED TO CARN VIEW SEVERAL YEARS AGO USED BY MR LANYON'S TENANT FOR ABOUT 2 YEARS (NO CHARGE) AND DISCONNECTED (BY CARN VIEW) WHEN OUR SURVEY STARTED IN 2015

STOP TAPS TURNED OFF ON 2 FEBRUARY 2015 (BY GOON FARM) AND CAUSED THE LEAK ON WINTER COTTAGE PIPE TO DISAPPEAR AND THE WATER PRESSURE TO INCREASE TO A LEVEL NOT EXPERIENCED FOR ABOUT 40 YEARS! TURNING OFF THIS TAP ALSO STOPPED THE SUPPLY TO THE TWO ANIMAL TROUGHS ON GOON FARM AND THE SUPPLY TO THE CABIN AND MR LANYON'S TENANT.

HOWEVER IT IS THOUGHT THAT THE LEAK STILL EXISTS (ON GOON FARM LAND) BECAUSE, EVEN WITH THE STOP TAP AT TAILINGS END TURNED OFF, A SMALL AMOUNT OF PRESSURISED WATER GETS THROUGH TO WINTER COTTAGE INDICATING THAT THE STOP TAPS DO NOT COMPLETELY TURN OFF AND ALLOWS WATER TO BACK FLOW FROM THE LEAKY (BUT STILL LIVE) SUPPLY ON GOON FARM.

SUPPLY ON GOON FARM CONNECTED AFTER THEIR ENTRANCE GATE BUT BEFORE THEIR METER (SUSPECTED MAIN LEAK)

STOP TAP AND METER ON GOON FARM TO HARMONY COTTAGE REMOVED WHEN HARMONY COTTAGE INSTALLED NEW PIE TO TAILINGS END
